# Champion Pump Station

## General Site and Safety Considerations

Tuesday, December 01, 2015

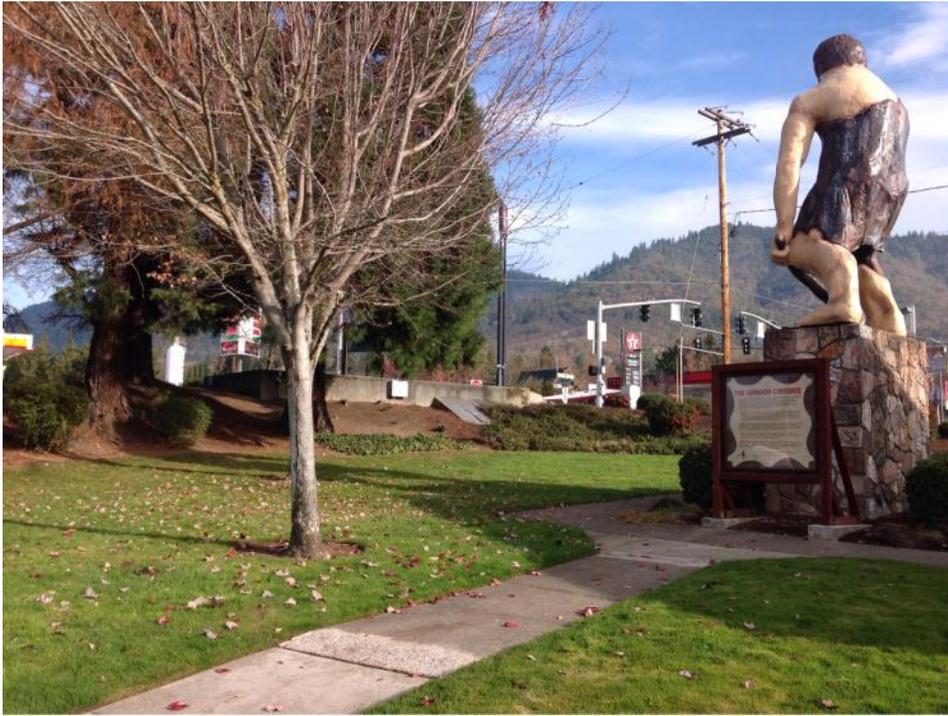
Site, looking north-northeast

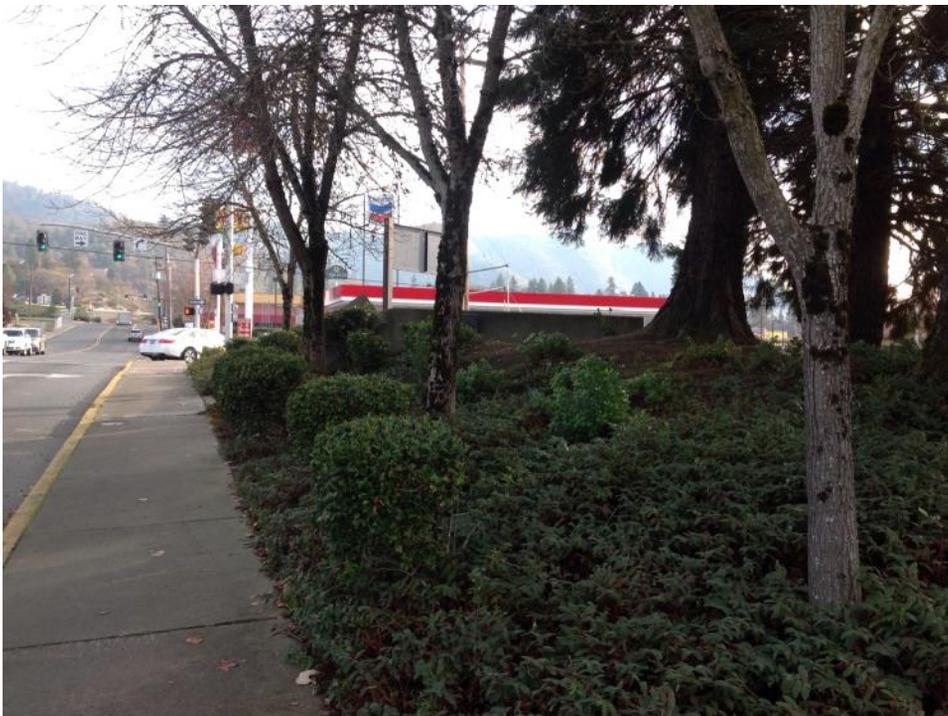
Site access, looking east on Morgan

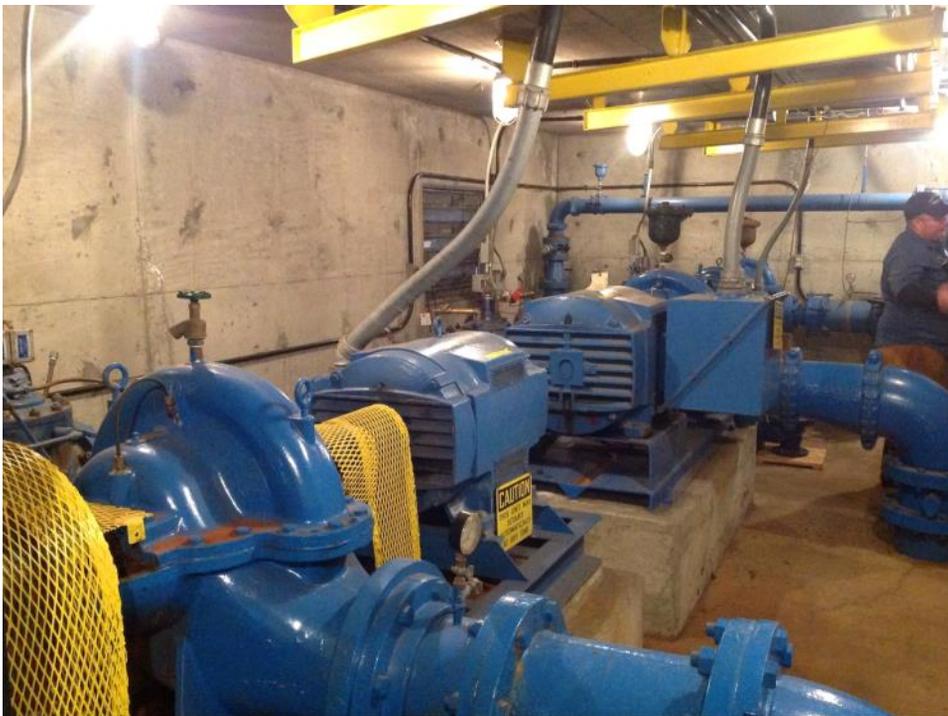
1. No floor drain. Drain was disconnected due to water draining across chamber of commerce parking area. The lack of drain has resulted in the station flooding.
2. Drainage is accommodated by collecting water in a basin and using a temporary pump to pump the water out to the landscape area.

View of interior showing pumps

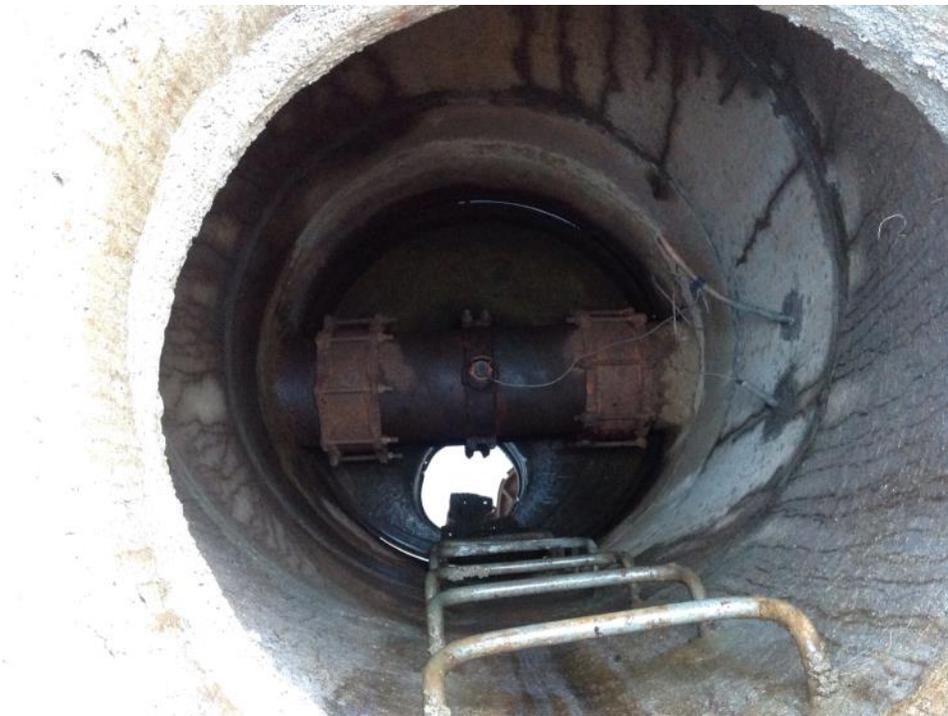
Meter is unreliable. Reportedly works with some pumps running but not others.

View of insertion meter from above

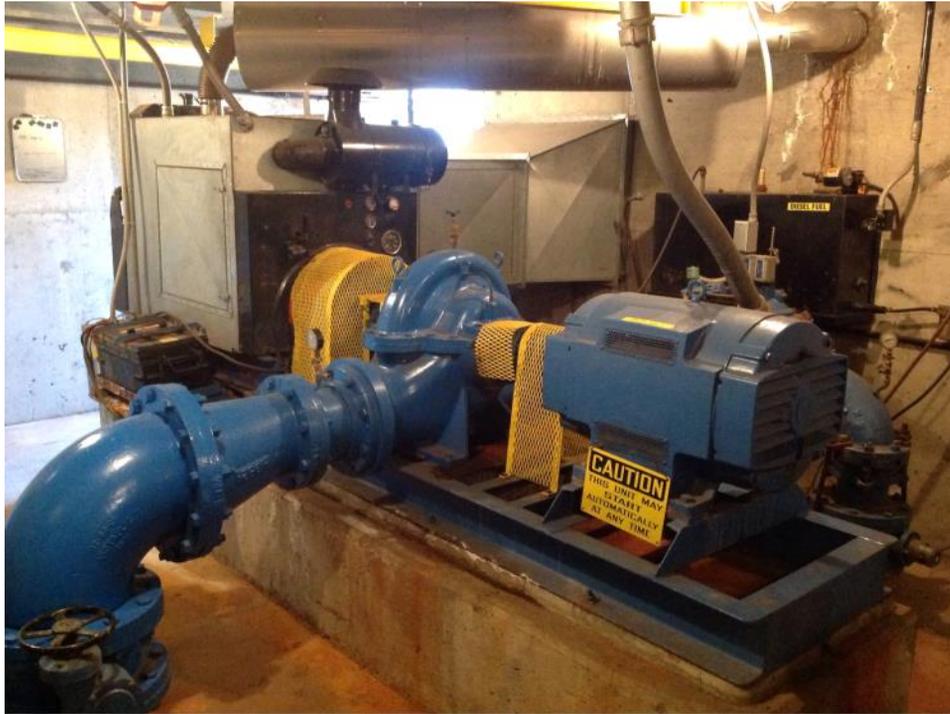
1. Dual driver on pumping system no. 1 with electric motor and diesel engine. Diesel engine is not functional/reliable.
2. Pumping system no. 1 is not in service due to failed control valve.

Pumping System No. 1 showing both diesel and electric drivers

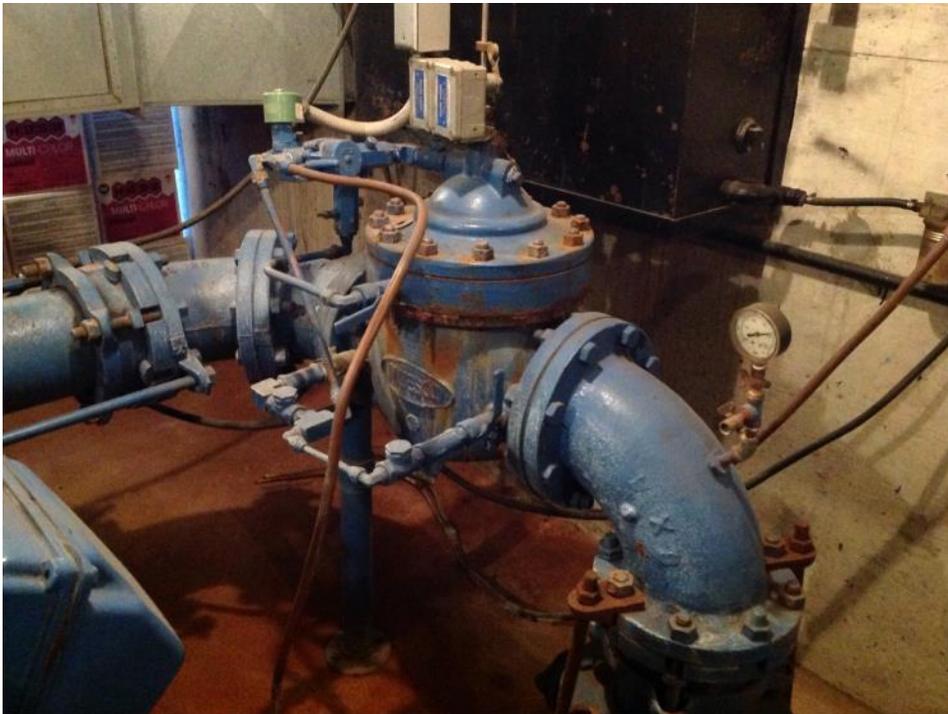
<b>Check/Control Valve</b>	<input checked="" type="checkbox"/> Yes <input type="checkbox"/> No
Reported/Exterior Condition	Reportedly not functional
Asset Nos.	FCV-7-13-1-2
Type/Manufacturer	MUESCO CALIFORNIA, MODEL: 7082-7
Age	Unknown

Pumping System No. 1 pump control valve (failed)

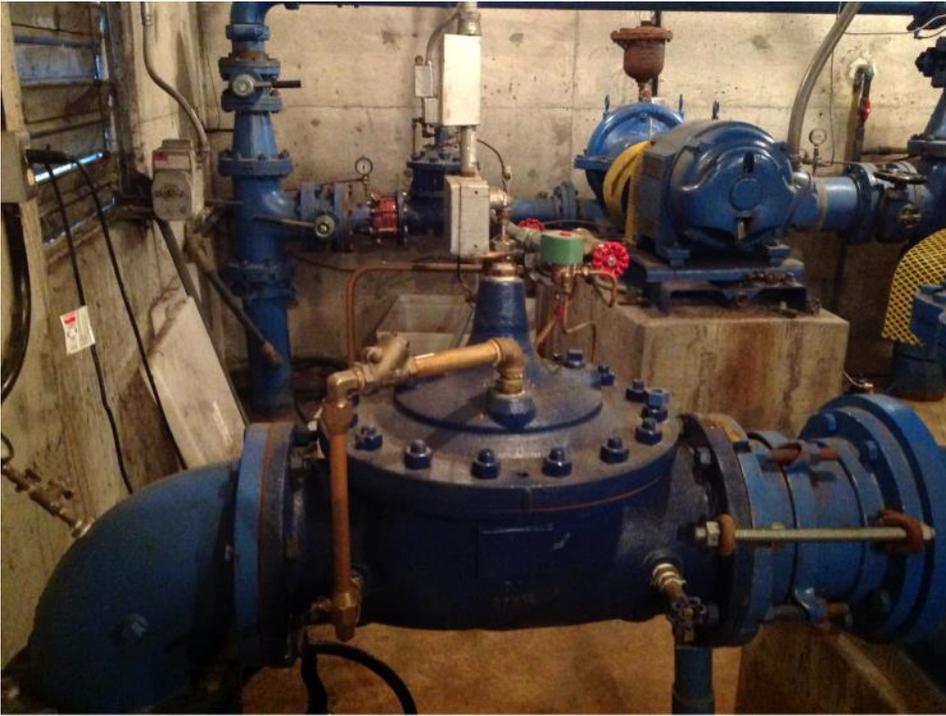
1. Pumping system no. 2 is not operational due to a failed control valve.

Pumping System No. 2 control valve
