Urban Forestry Advisory Committee Photo Inventory Summary

August 17, 2006

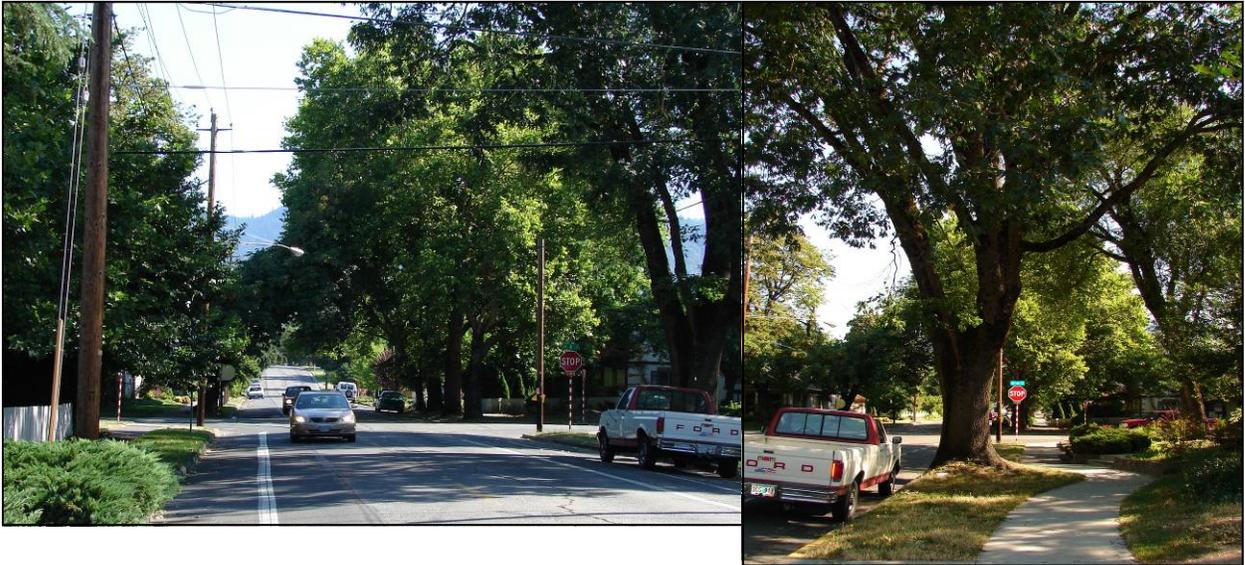
These old trees and good shade providers are on 4th near A:

4th St. is attractive and, most importantly at this time of year, cool and inviting due to the mature trees which line it. However, some of these areas have damage to the older, larger canopied trees where a “tunnel” was cut through the canopy to accommodate power lines. The tree in the left photo is a native black oak.

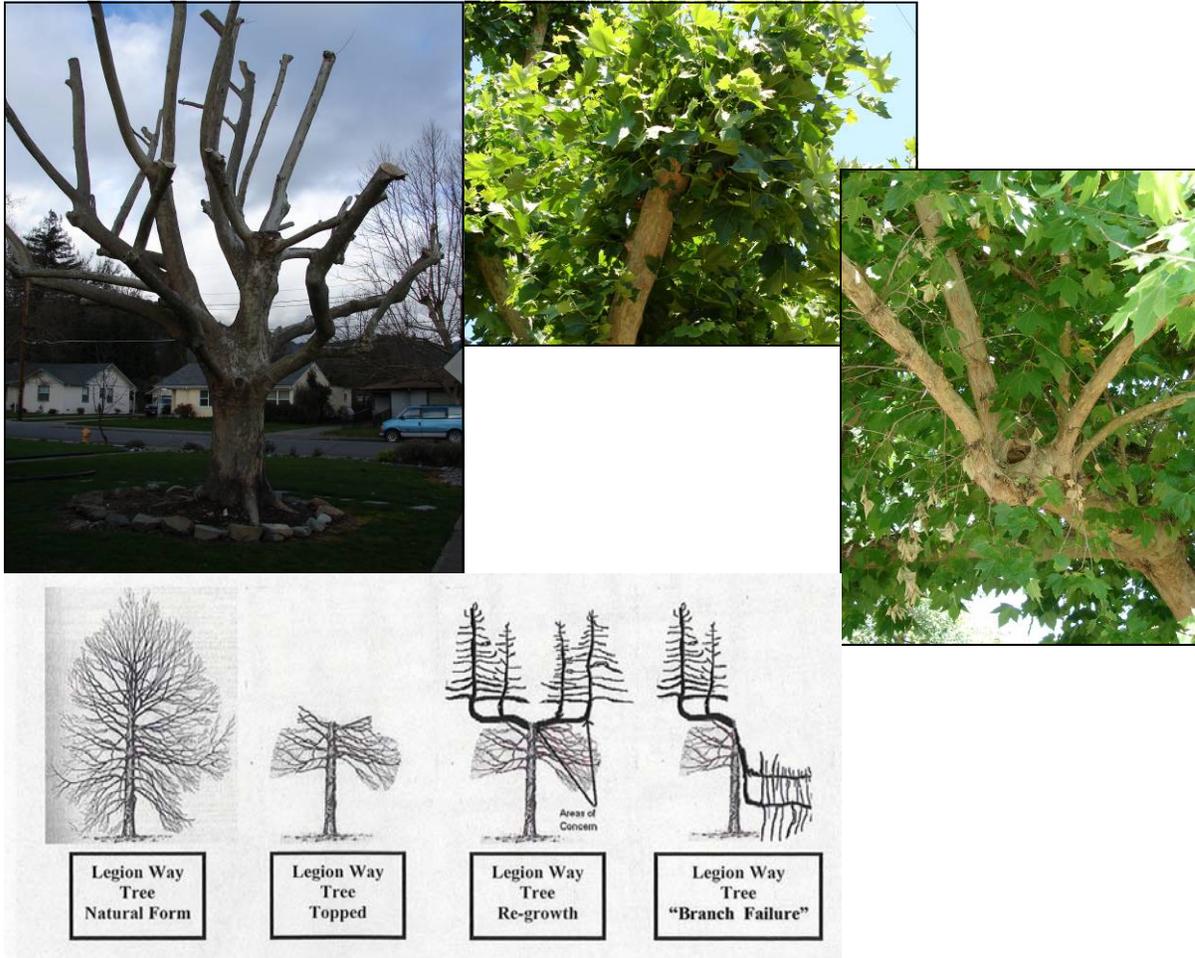
Topping is the severe cutting back of limbs to stubs larger than three inches in diameter within the tree's crown. This results in a large number of small shoots growing up around each stub. The sequence of these photos was taken this year on Dean Street.

Each shoot's connection to the stub is weak and as the shoots grow into limbs they become large weights which can easily break off and cause damage. See sample depiction above. Topping is done to limit the size of the tree. It used to be called "pollarding" and was a common cure for the sycamore's tendency to outgrow its space. It's now disapproved by the National Arbor Day Association and the International Society of Arboriculture.

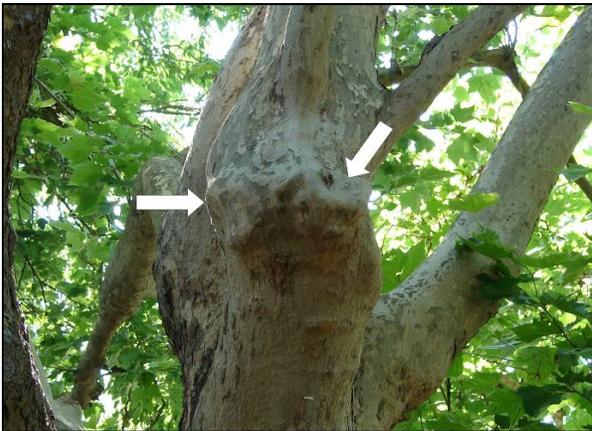
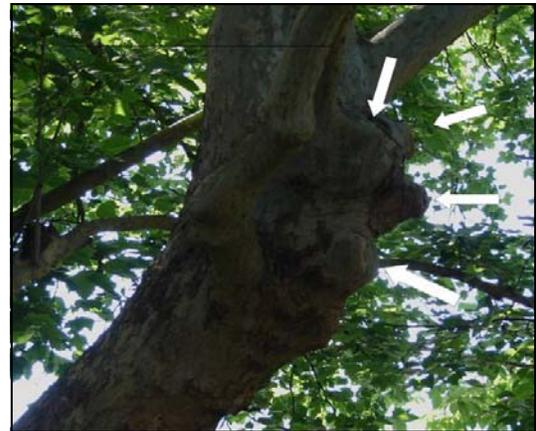
Sycamore on Ashley Place south of N St.

When taking a closer look at the sycamore, there is evidence that it was “topped” when it was younger. Fortunately for the Ashley Place homeowner, someone reversed the effects of the pollarding by cutting several of the weak shoots and allowing just a few strong branches to develop. The scars of those branches are evident in these photos.

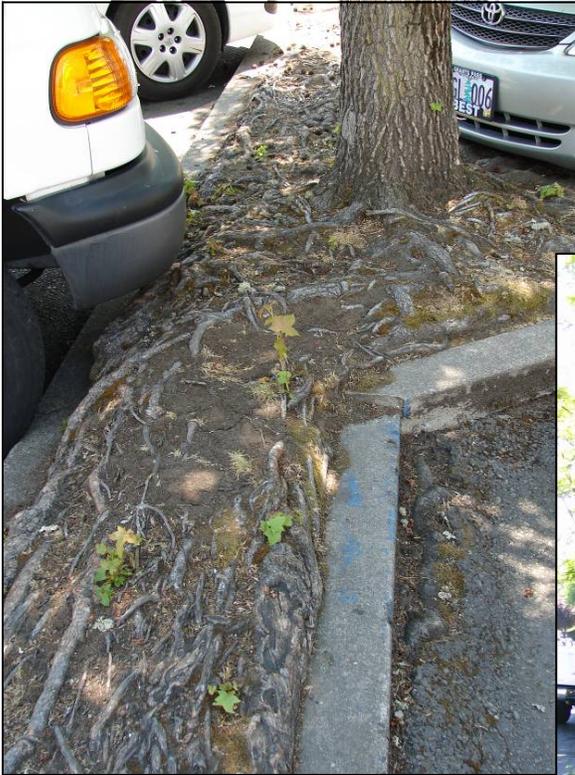
The city discourages planting some species of maples as street and parking trees because their roots tear up sidewalks and foundations as can be seen in this photo taken in a downtown parking lot.

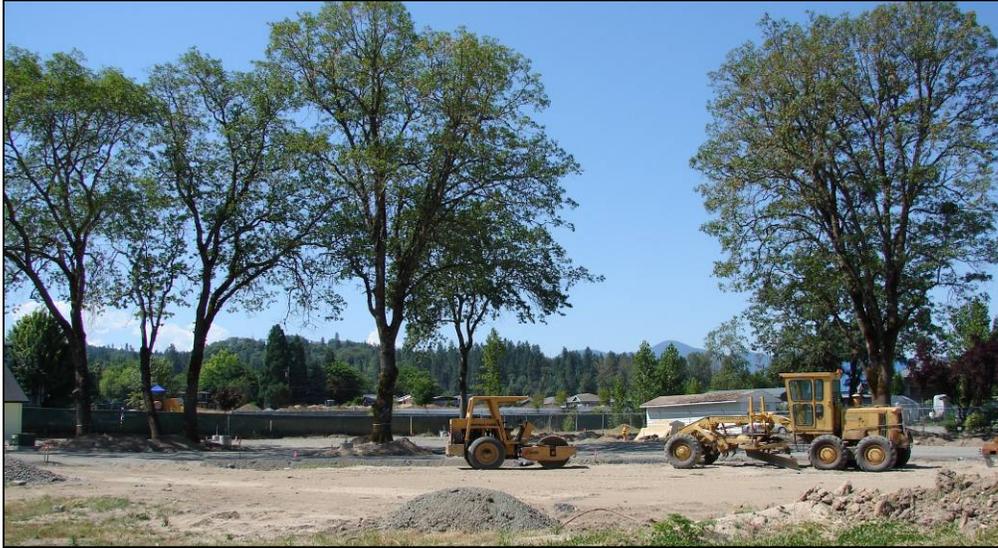
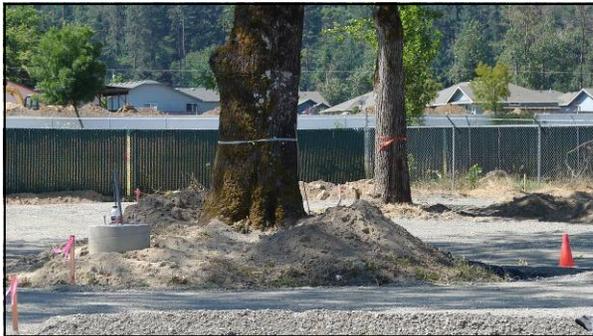
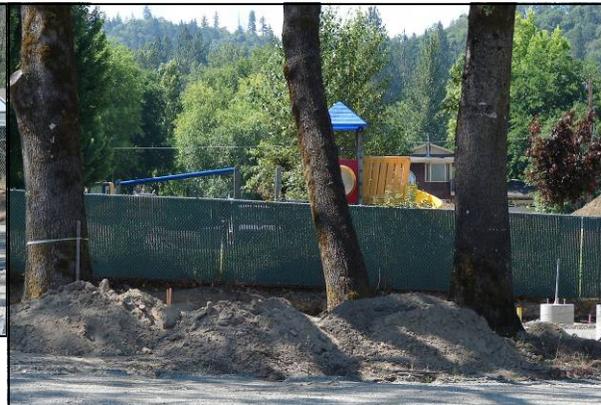
This may be both a best and a worst example. The construction requirement was to retain six mature black oaks. In addition, the parking lot is to have a minimum number of parking spaces based on the number of businesses as well as creating sufficient slope to the ground for rainwater runoff. Below are a few photos of the area as it appeared during construction.

Here are a few closer views of the trees in which we can see three causes for concern.

Part of the top soil was removed to accommodate drainage requirement. The packed road surface appears to be within the drip line of the tree, close enough to impact the roots. Over a foot of soil was deposited at the base of the trees which could smother the roots of mature trees.

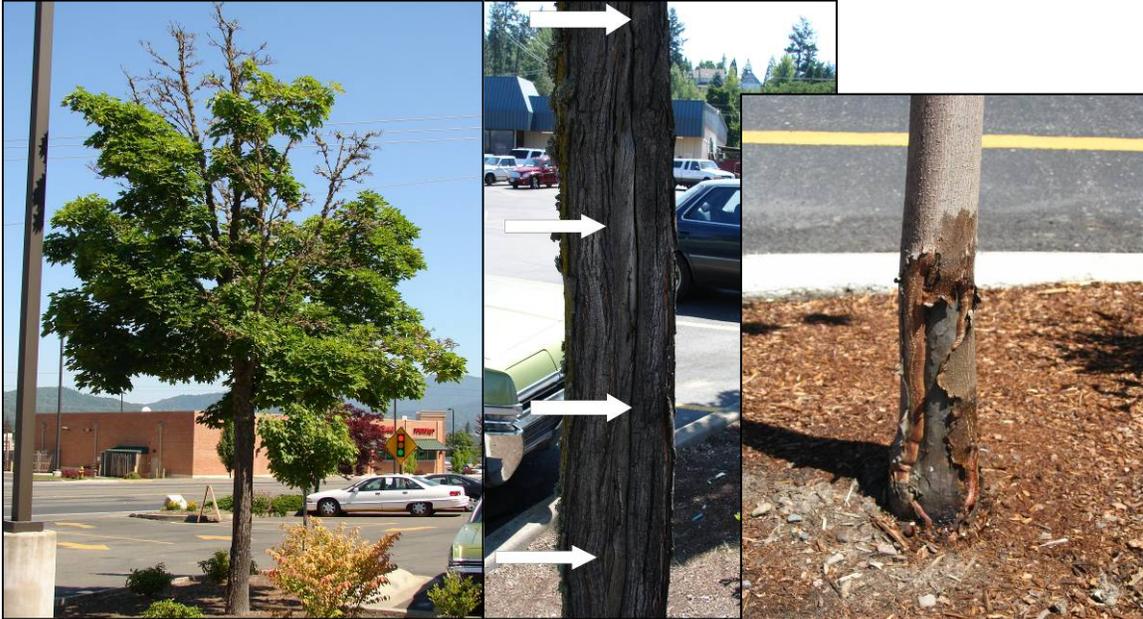
Sunscalding. This maple has been in the ground several years and should have a healthy canopy. It's planted in good soil and irrigated, but at least three limbs are dead, one of which is the leader, as a result of sun scald.

Sun scald occurs when the bark of a tree is warmed by the winter sun, usually on the southwest side of the trunk. The bark and cambial tissues deacclimate and are not able to reacclimate quickly enough when the sun sets and the temperature drops abruptly. The result is damage or death of tissue, frequently of saplings that are too young to develop an insulating layer of corky bark¹.

This condition is evident in missing bark on the sun exposed side of the tree. The main problem is the missing bark which contains the tree's cambium layer. Without it the tree is not producing those cells which allow transportation of water and nutrients between leaves and roots. As a sapling, the tree lost a considerable amount of its circulatory system. The same is true for these stunted maples which have been standing against the Fred Meyer west wall for over 15 years. Even some street trees, planted and maintained by the city, have this problem. These trees do not recover and will not be able to develop into the mature canopy trees desired. Sunscald may affect as many as $\frac{1}{4}$ of new plantings.

Sunscald on trees can be prevented by wrapping the trunks with a commercially available tree wrap, burlap, or agricultural fleece. Painting the bark of young trees with white interior latex paint mixed with water (1:1 in the fall), is also an effective method. The light color reflects the sun's rays and prevents sudden temperature changes. Dark-colored mulching material will also absorb the sun's heat, rather than reflecting it onto the tree's trunk.

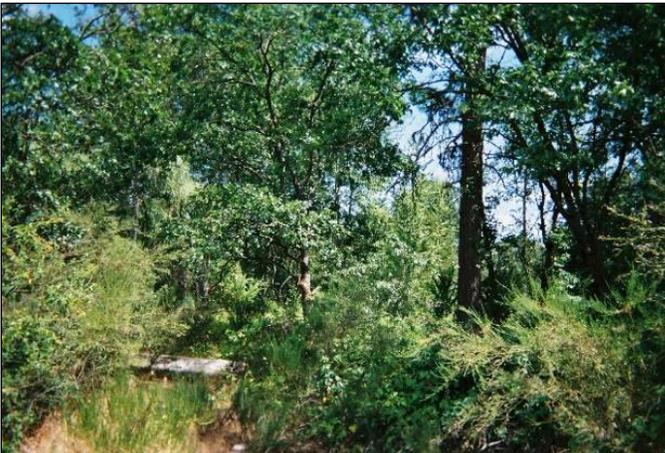
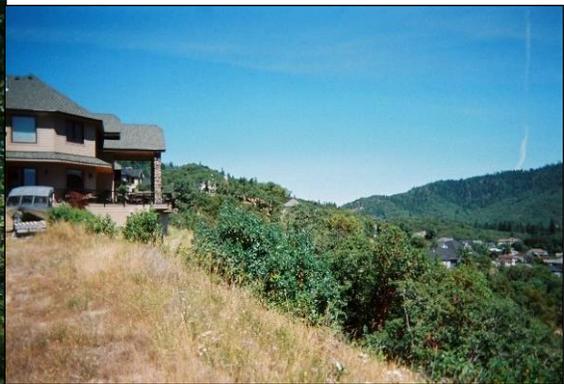
Brush field adjacent to new development, is a potential fire hazard.

Photo above captures an area that is a potential fire hazard. Dense ladder fuels are present. Should a fire start in this area, the ladder fuels could quickly carry the fire through the tree crowns and to the upper canopy resulting in stand loss.

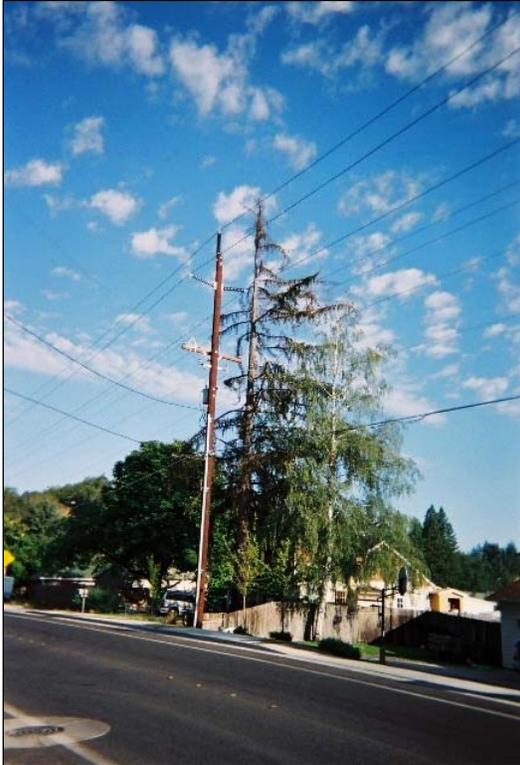
The incense cedar, above, has lost the majority of its branches on the side adjacent to the powerline. Further research is needed to determine whether the powerline is the cause or if there is some other factor.

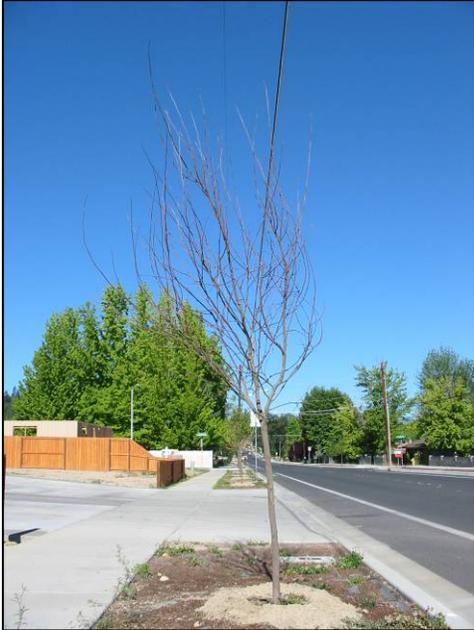
Western Redbud with no irrigation. A larger tree could have been planted in this size planter strip. Along this street over two thirds of this variety of tree have perished. Though not certain, lack of water may be the reason. The other tree variety planted in this area is the flowering pear. They have had a better survival rate.

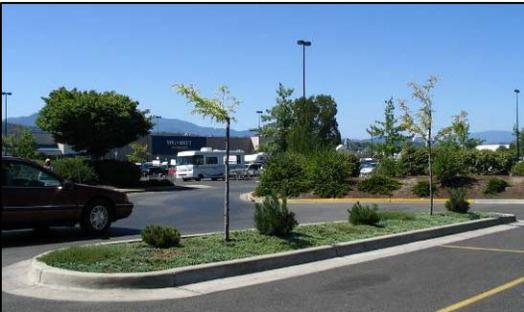
Furthest tree at left has no lower branches and is missing half its canopy. Further investigation is needed to determine cause, such as whether poor soil conditions, or other inadequate conditions, are present.

A poor tree choice for an approximately 15 acre parking lot that has little canopy and provide essentially no shade.

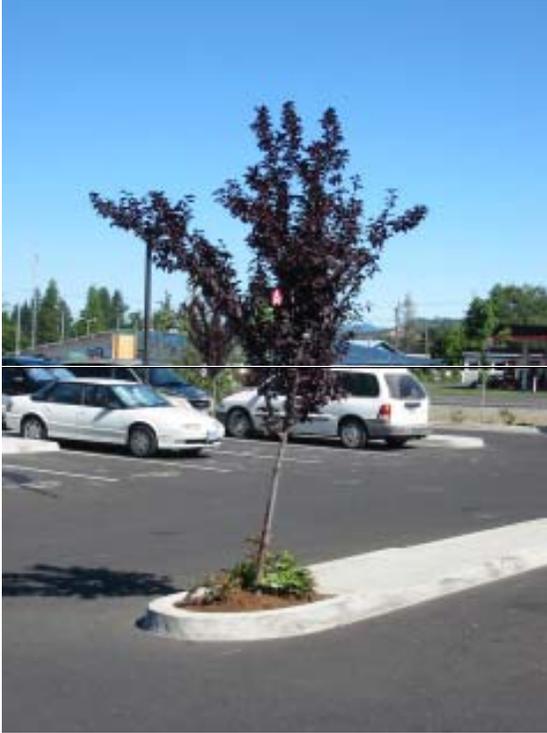
This planter is more suited for a light standard than a tree that would spread to at least 15 ft in well suited conditions. This space is 18 inches x 36 inches and the tree has been backed into by a vehicle.

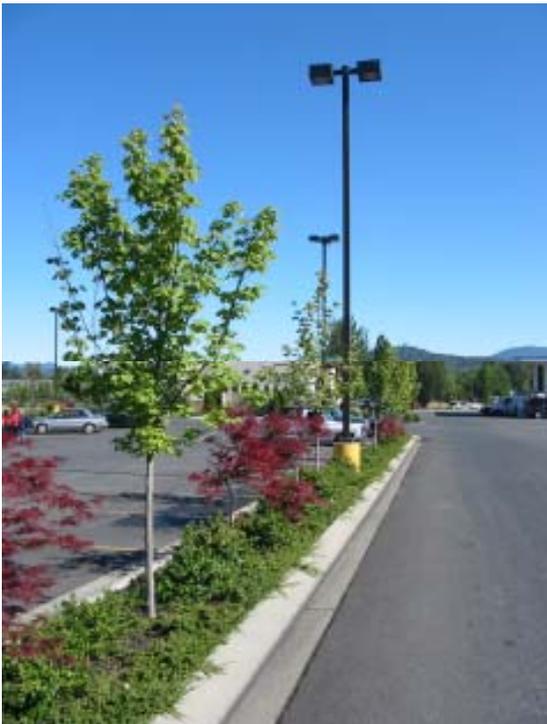
The theme of the larger trees is appropriate for this parking lot, however the smaller laceleaf japanese maple is not appropriate for this location since its full potential size will remain relatively small and its dislike of radiant heat.
