Urban Forestry Advisory Committee Photo Inventory Summary

August 17, 2006

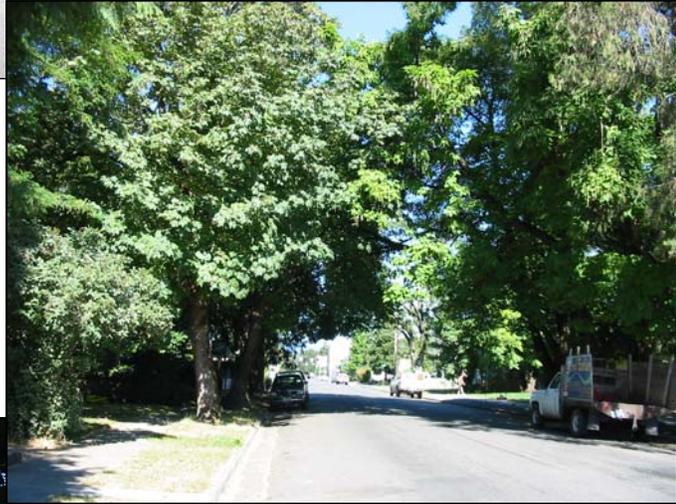
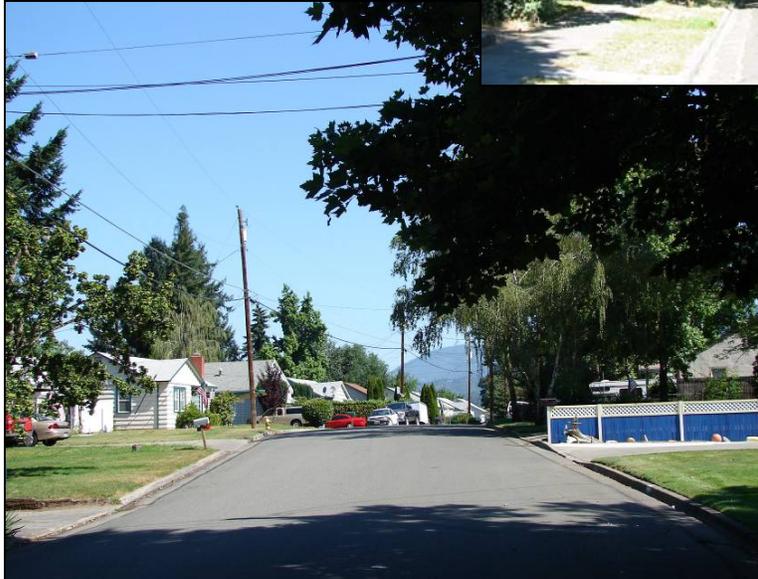
Along Ashley Place, there is a significant difference between the two sides of the street. The right side has mature attractive trees shading houses and yards. The left side has power lines and little else. There are no sidewalks or planter strips, so in front of each house only the small front yard offers space to plant trees. This is sufficient space on the right side of the street, but the power lines on the left leave little room in front yards for trees, the space is more suited for large shrubs and a few small decorative trees. Room for larger trees is on the left in the side and back yards.

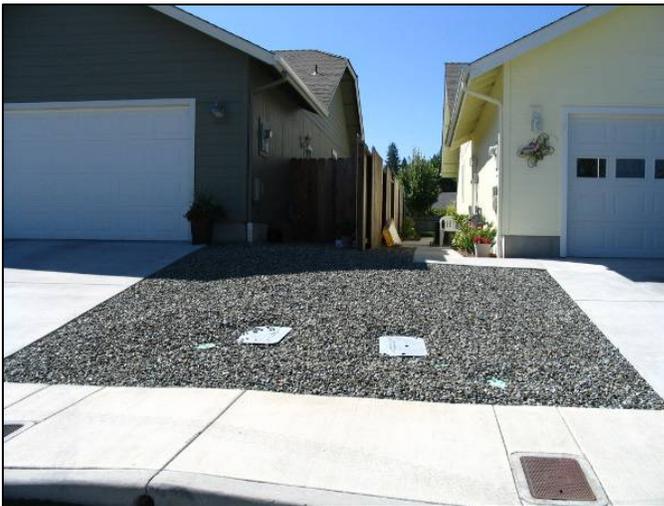
No trees or vegetation planted on boundary of properties throughout this particular neighborhood west of Redwood Avenue.

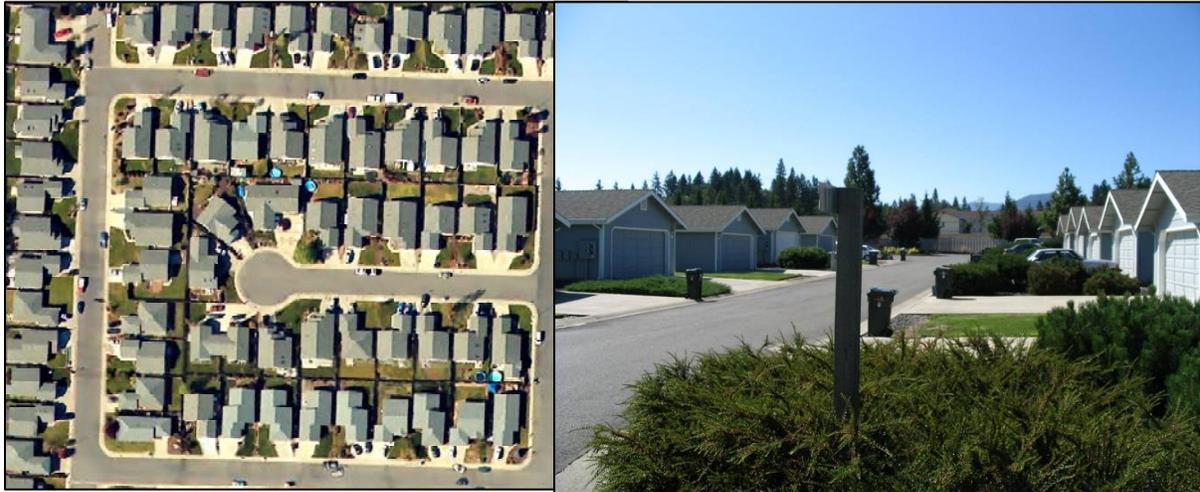
The aerial photo (at left) illustrates the lack of sizable canopy trees in this neighborhood. View within the neighborhood (at right) is the same area as seen from aerial (above). Many front yards have no trees. Though the neighborhood interior photos demonstrate there is insufficient to no canopy providing trees, the aerial is a more dramatic visual representation of this fact.

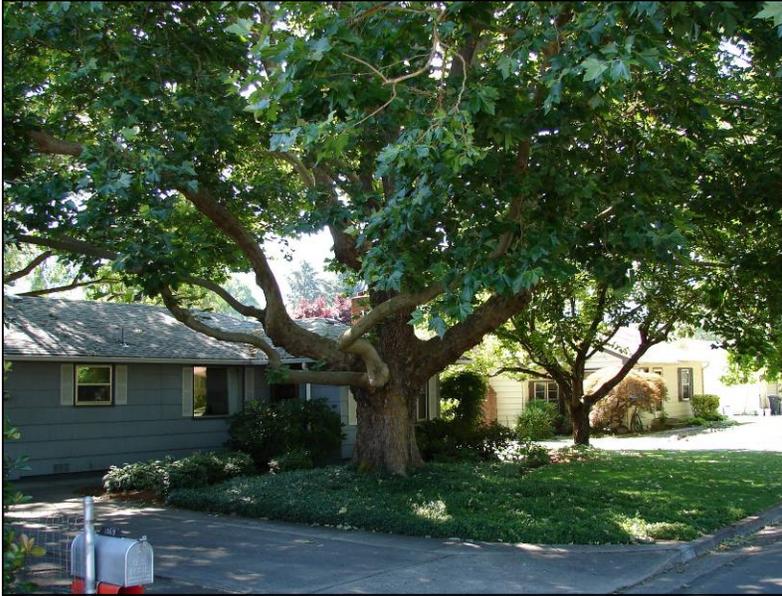
Sycamore on Ashley Place south of N St.

The ranch houses in this area were likely built in the 1950s or 1960s and have reached mature status. Notice the shade, the tree is likely keeping this house several degrees cooler than the neighbor's house with no shade.

When taking a closer look at the sycamore, there is evidence that it was “topped” when it was younger. Fortunately for the Ashley Place homeowner, someone reversed the effects of the pollarding by cutting several of the weak shoots and allowing just a few strong branches to develop. The scars of those branches are evident in these photos.

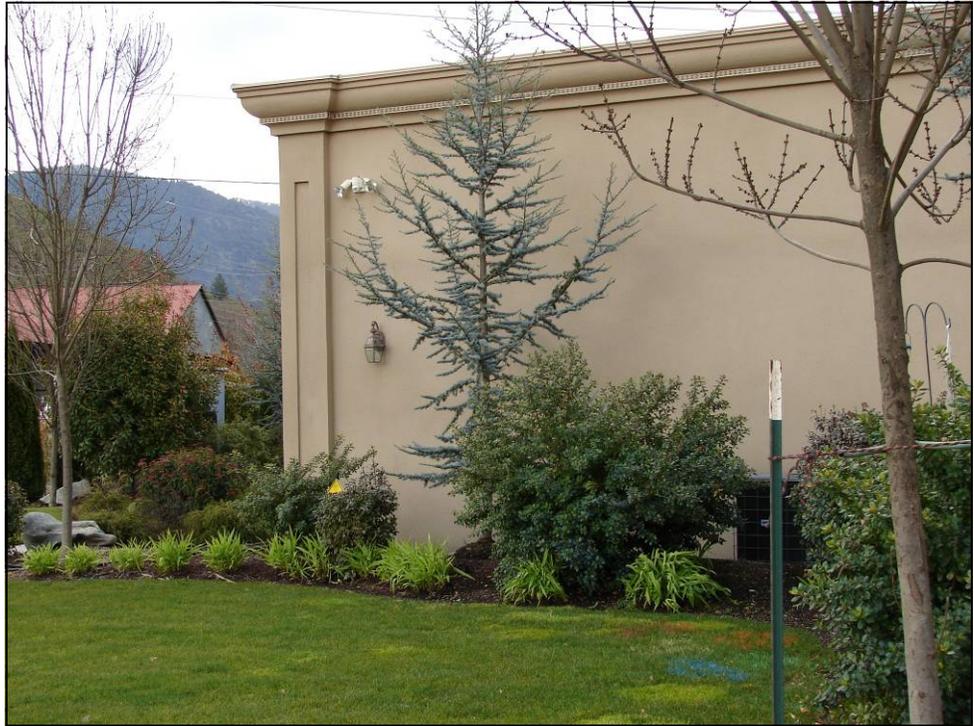
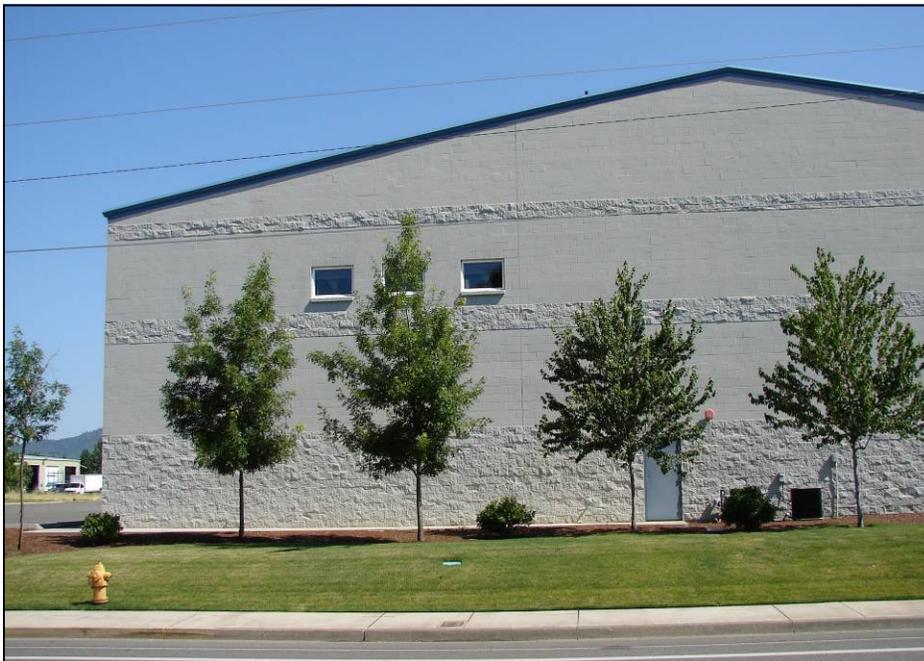
The same idea is at work at this industrial building on M St., although less effective.

The uniform use of trees (placement, size of trees, and same species) attracts more attention to the building's outline. Diversity attracts the eye when trying to camouflage from a large basic structure.

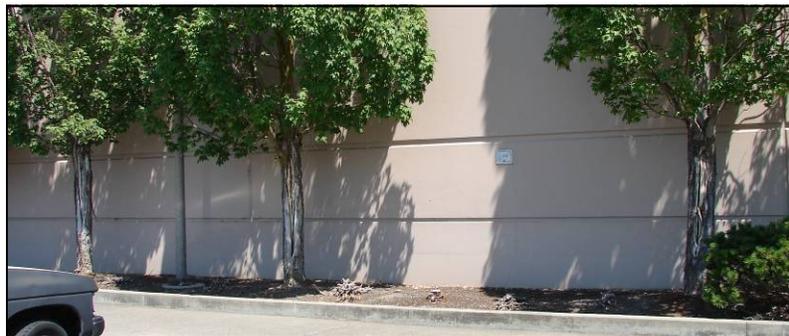
Sunscalding. This maple has been in the ground several years and should have a healthy canopy. It's planted in good soil and irrigated, but at least three limbs are dead, one of which is the leader, as a result of sun scald.

Sun scald occurs when the bark of a tree is warmed by the winter sun, usually on the southwest side of the trunk. The bark and cambial tissues deacclimate and are not able to reacclimate quickly enough when the sun sets and the temperature drops abruptly. The result is damage or death of tissue, frequently of saplings that are too young to develop an insulating layer of corky bark¹.

This condition is evident in missing bark on the sun exposed side of the tree. The main problem is the missing bark which contains the tree's cambium layer. Without it the tree is not producing those cells which allow transportation of water and nutrients between leaves and roots. As a sapling, the tree lost a considerable amount of its circulatory system. The same is true for these stunted maples which have been standing against the Fred Meyer west wall for over 15 years. Even some street trees, planted and maintained by the city, have this problem. These trees do not recover and will not be able to develop into the mature canopy trees desired. Sunscald may affect as many as $\frac{1}{4}$ of new plantings.

Sunscald on trees can be prevented by wrapping the trunks with a commercially available tree wrap, burlap, or agricultural fleece. Painting the bark of young trees with white interior latex paint mixed with water (1:1 in the fall), is also an effective method. The light color reflects the sun's rays and prevents sudden temperature changes. Dark-colored mulching material will also absorb the sun's heat, rather than reflecting it onto the tree's trunk.

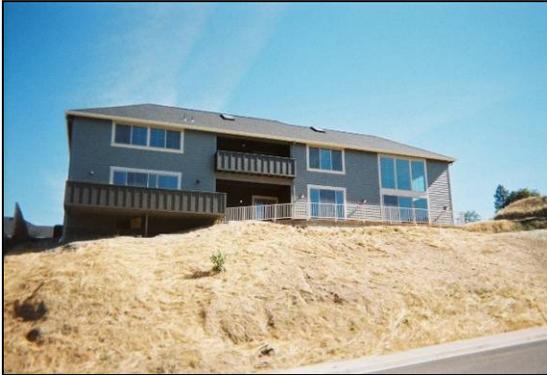
Hillside development without trees

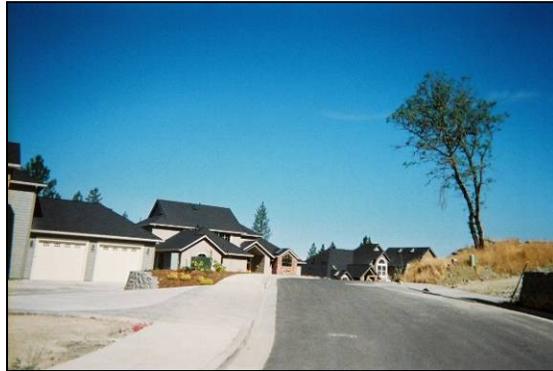
Remaining trees ineffective in providing adequate shade

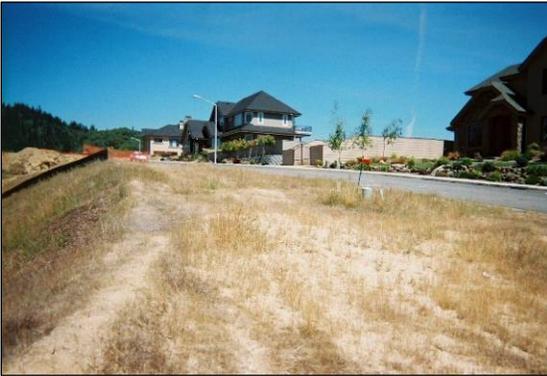
Although trees may be planted, due to the extensive amount of earth moved, the success of any planted trees is greatly compromised. This is because nutrients trees need are in the first few inches of topsoil and once removed, it takes years for it to return.

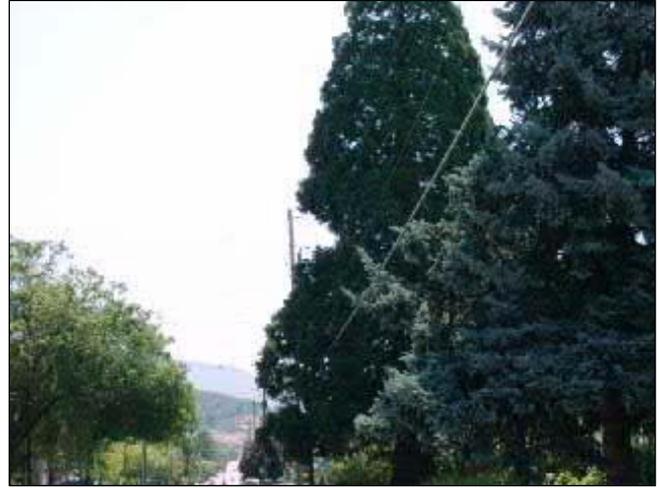
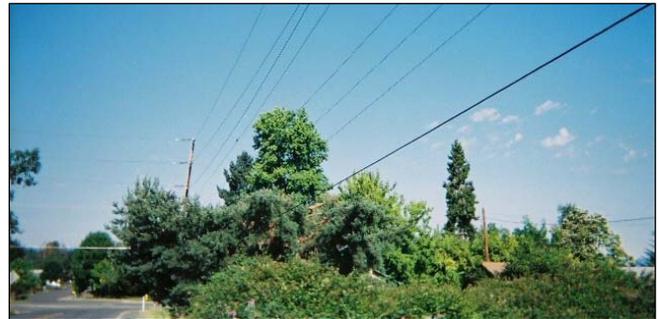
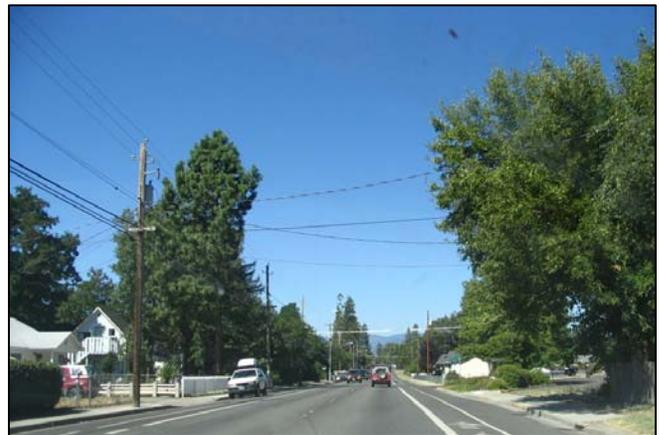
The trees, directly above, appear to be coexisting adjacent to, around, and/or through powerlines without creating damage to the powerline and vice versa.

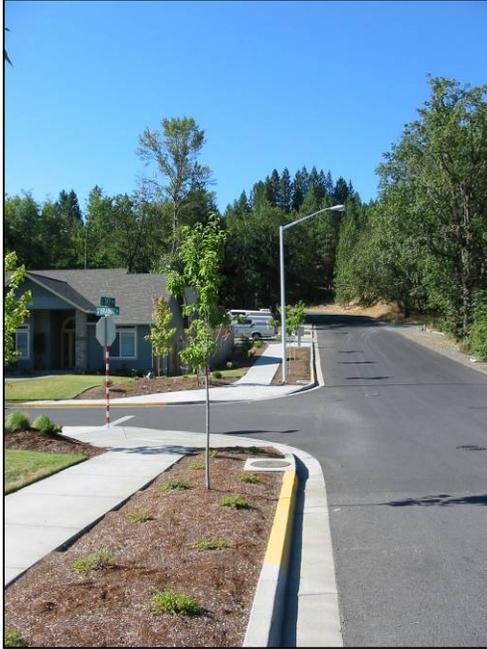
Trees too small for planting devices and surrounding conditions

New subdivision street tree planting. Trees are upright flowing pears (no overhead powerlines) to limit selection of a taller and denser canopy tree. Trees are irrigated and are on east side of street.

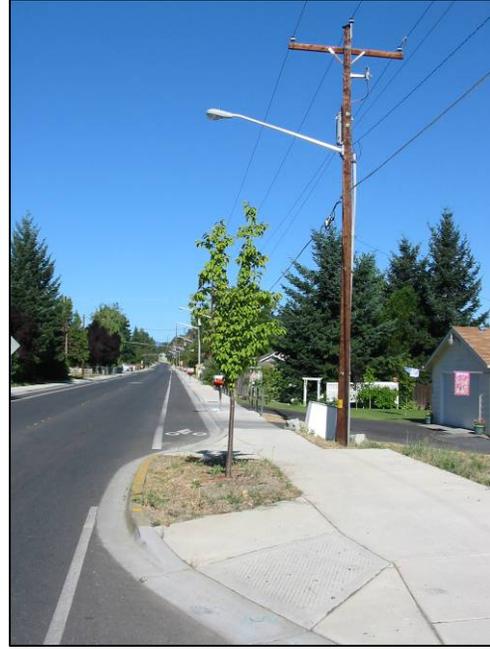
Newer street tree in traffic calming device. Tree is not located under power lines although the tree that is planted is a low growing flowering cherry.

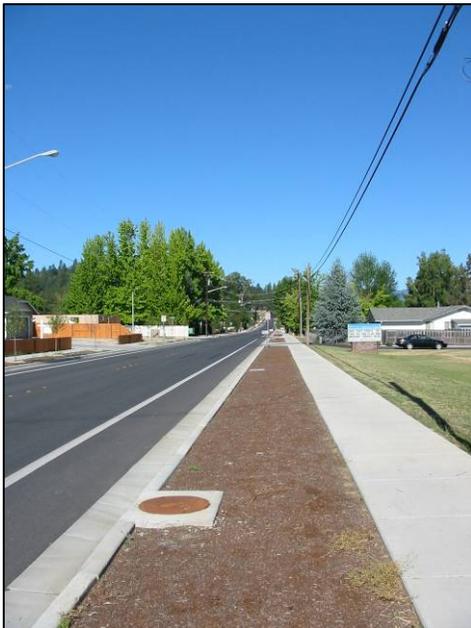
West Harbeck Road. Street planter strip not planted with trees as adjacent property is vacant.

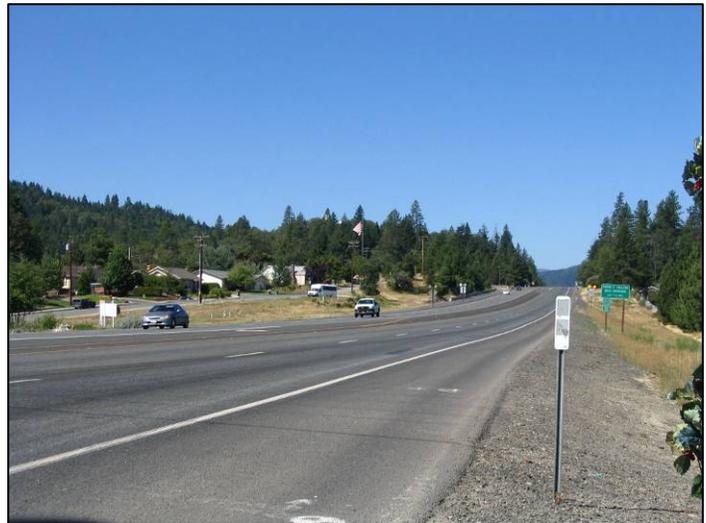
Gateway location into the city along Redwood Highway. No trees planted along median.

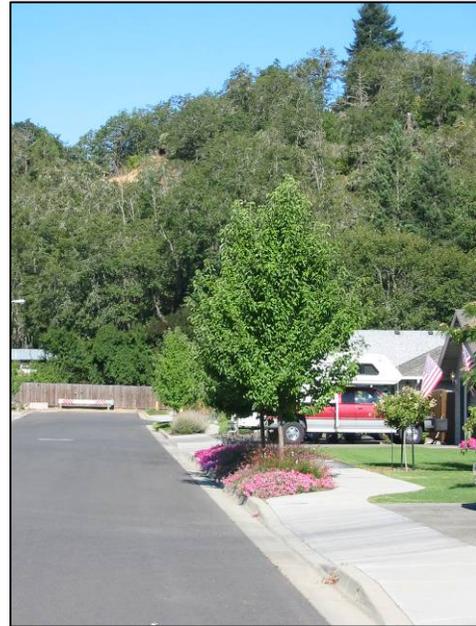
Street Trees – newer subdivision with 5 ft planting strip. All trees in this subdivision are upright flowering pear. Planters are irrigated. There is a noticeable difference between the canopy conditions between this photo and the one at left.

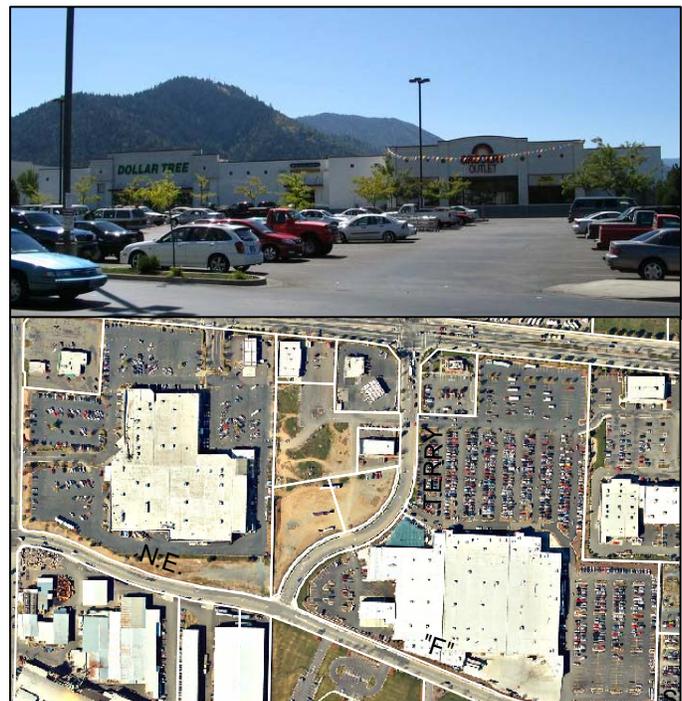
The aerial above demonstrates the lack of canopy cover in general over approximately 35 acres.

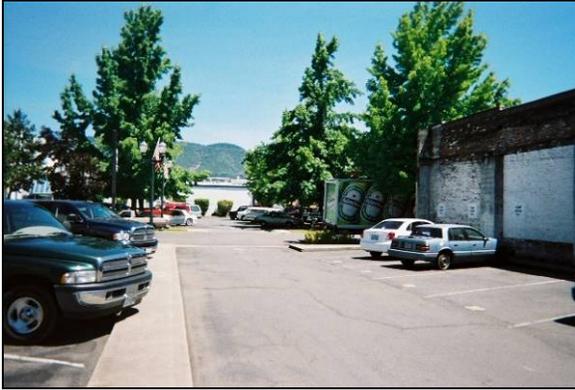
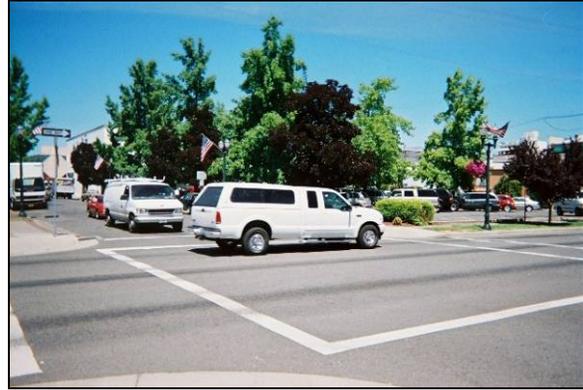
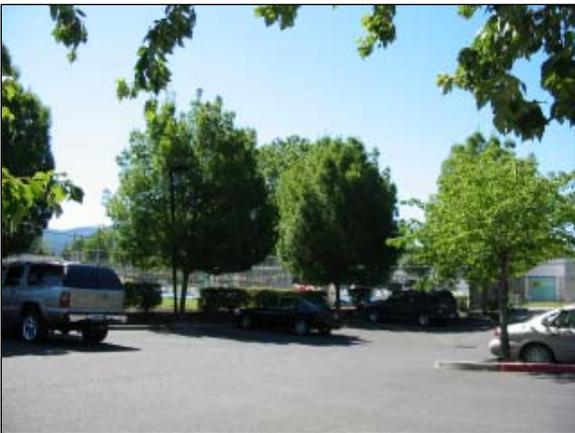
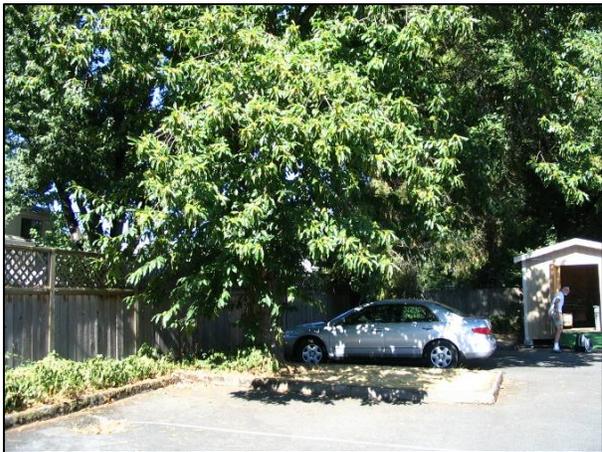
Above three photos, show fairly new parking lots with medium sized tree species. Offers good shade presently and will give more in coming years.

This single tree is providing considerable shade. The health of this tree may be a result of the contiguous planter strip to other portions of vegetated land. See diagram below.

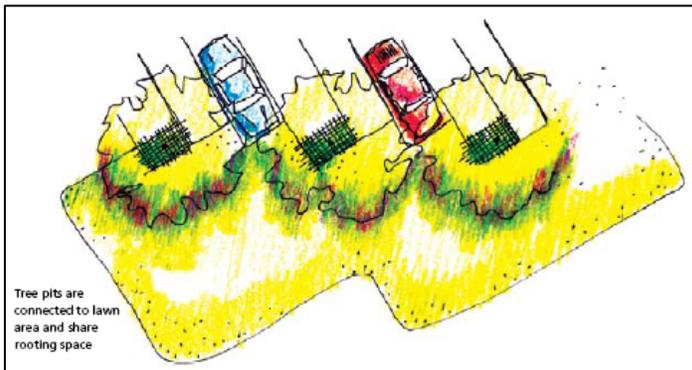
Many planter strips only contain portion 1, while the situation within the photo at left contains portions 1 and 2. Such a situation allows for wider reach of the tree's root system.

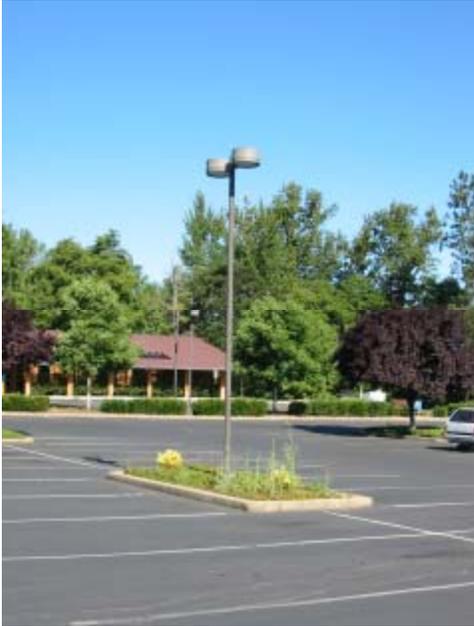
Had light been placed in a stall, this planter could support a tree.

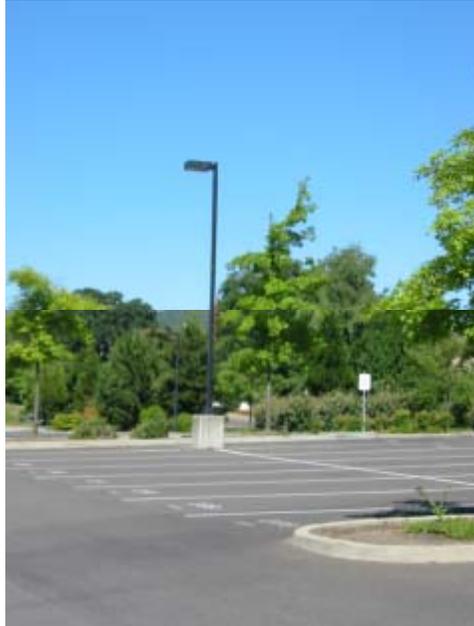
Better use of space and planters for trees.

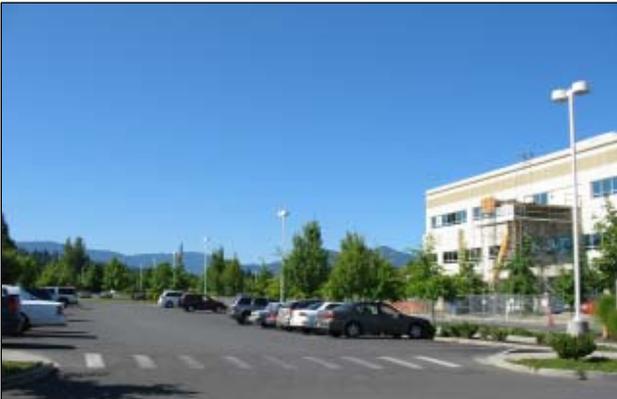
Another good example of a young parking lot tree planting. The species of trees selected will provide ample shade once trees reach maturity.

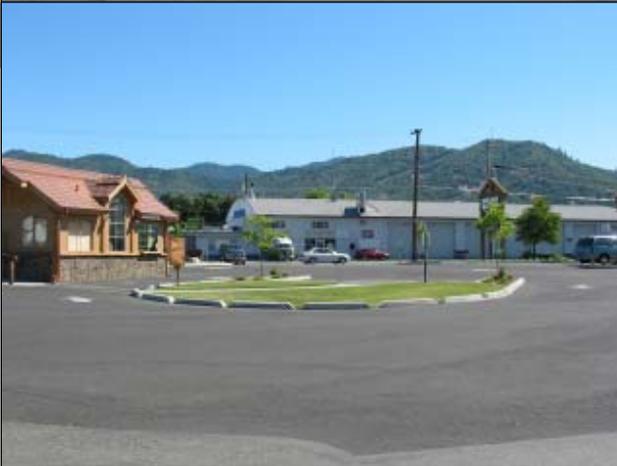
This example shows a large expanse of asphalt, with a large expanse of turf. There are two flowering dogwoods in the very narrow parking islands. The 20 x 20 ft lawn area presents an excellent opportunity to provide one or more large shade trees. Given that this lawn area also serves stormwater runoff a large canopy tree would be well suited here.

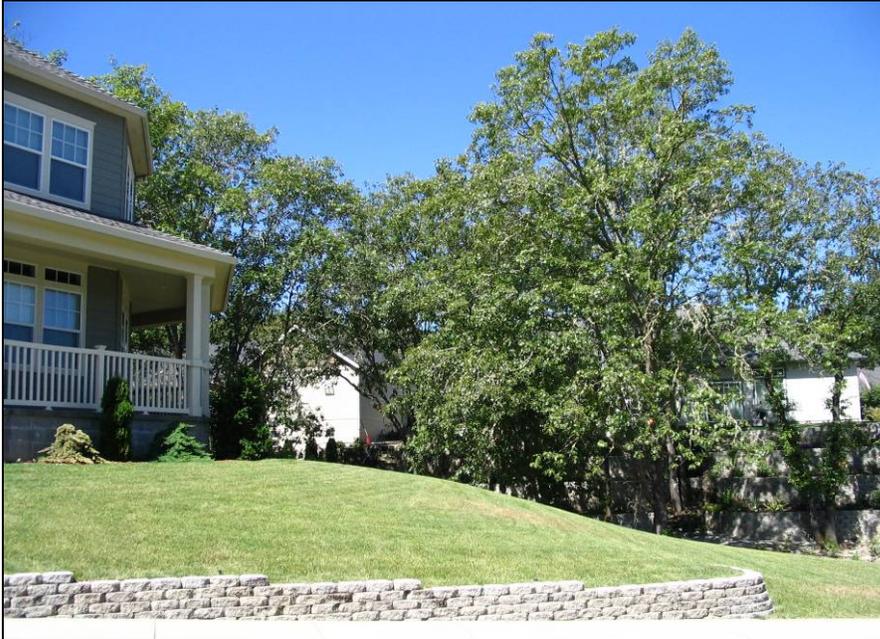
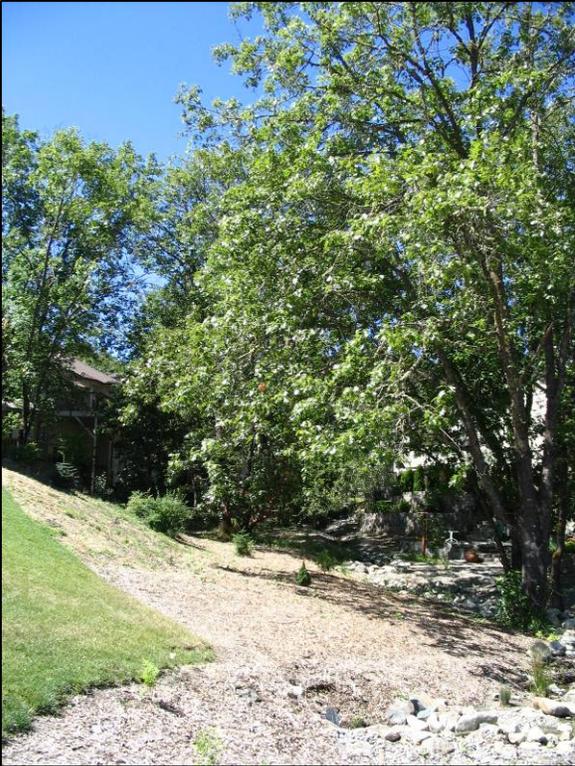
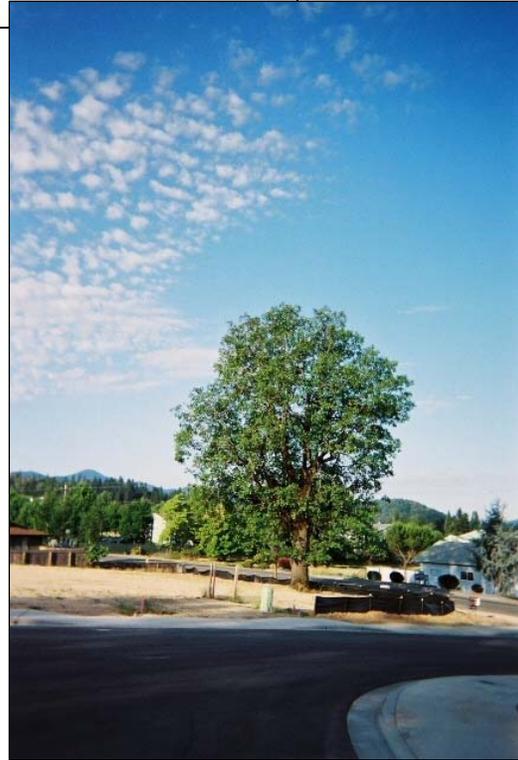
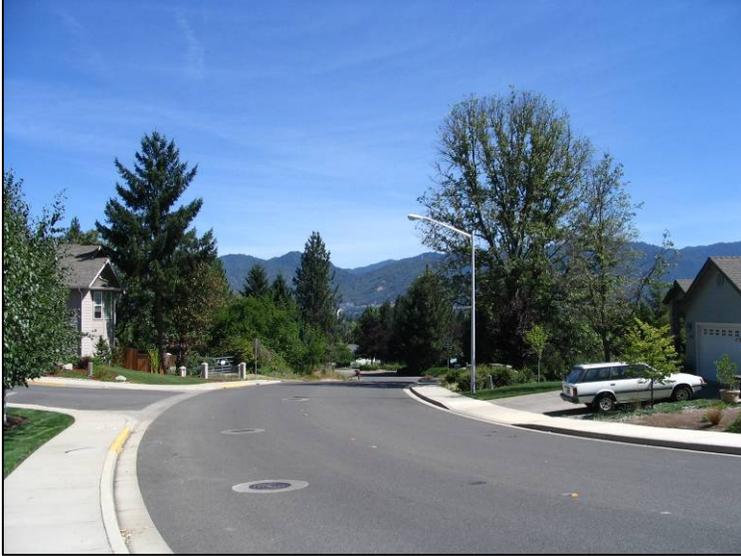
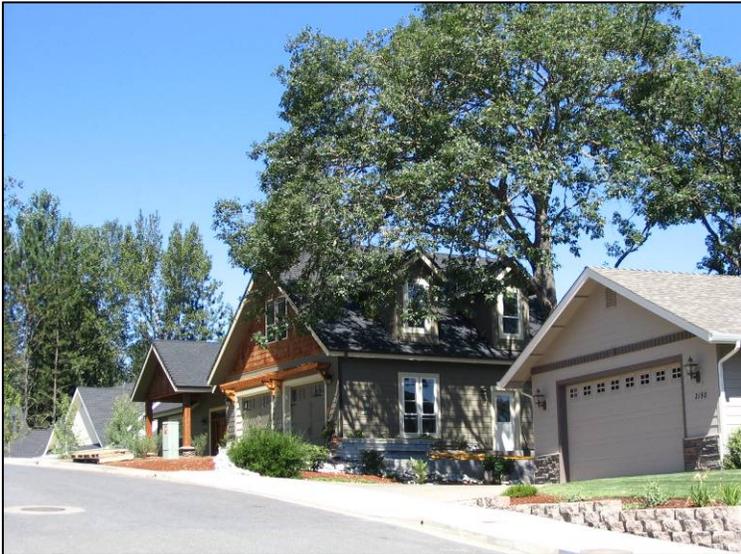
These trees are likely to remain intact as long as damage has not occurred to the roots and top soil nutrients remain after construction.

These photographs (this and the previous page) are all from the Meadow Wood Subdivision in Grants Pass. This subdivision represents excellent retention of pre-development trees with post-development homes. 84% of significant sized trees were retained. Significant trees are defined as having a diameter, of a tree measured 4.5 ft from the base of the tree, greater than 12 inches or 24 inches for a Madrone.

This is well in excess of the 60% retention rate required by the *City of Grants Pass Development Code*.

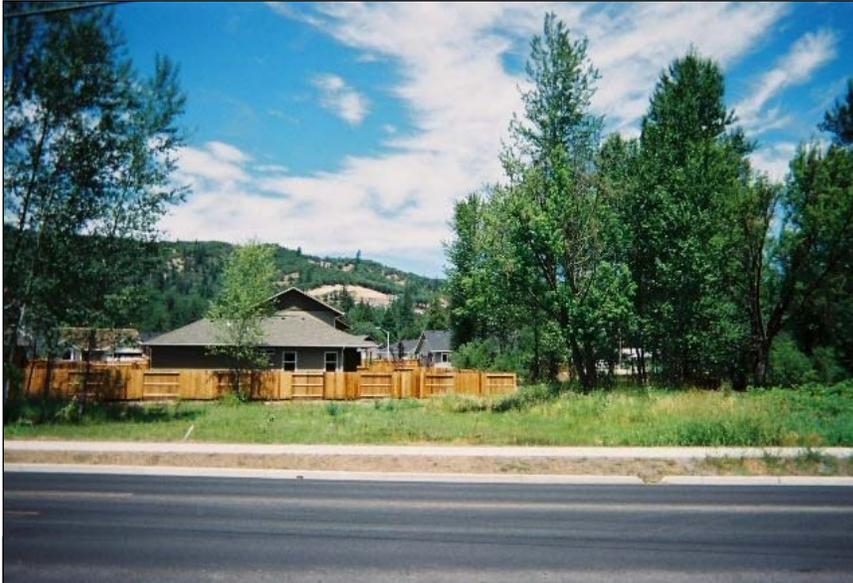
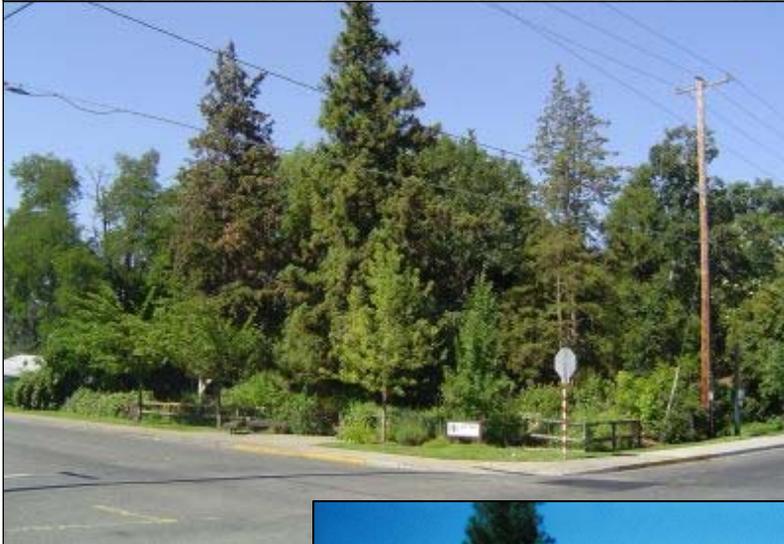
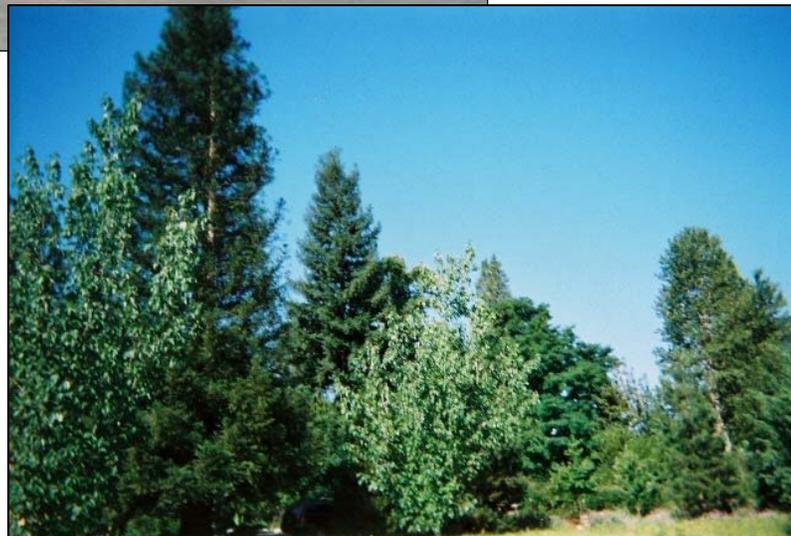
These photos represent areas in the community with diverse tree species retained after development. Diverse stands of trees are more resilient to disease, drought, and other forms of environmental stress as well as contribute a wide variety of environmental benefits for storm water retention, nutrient cycling, processing air pollution, and wildlife habitat.

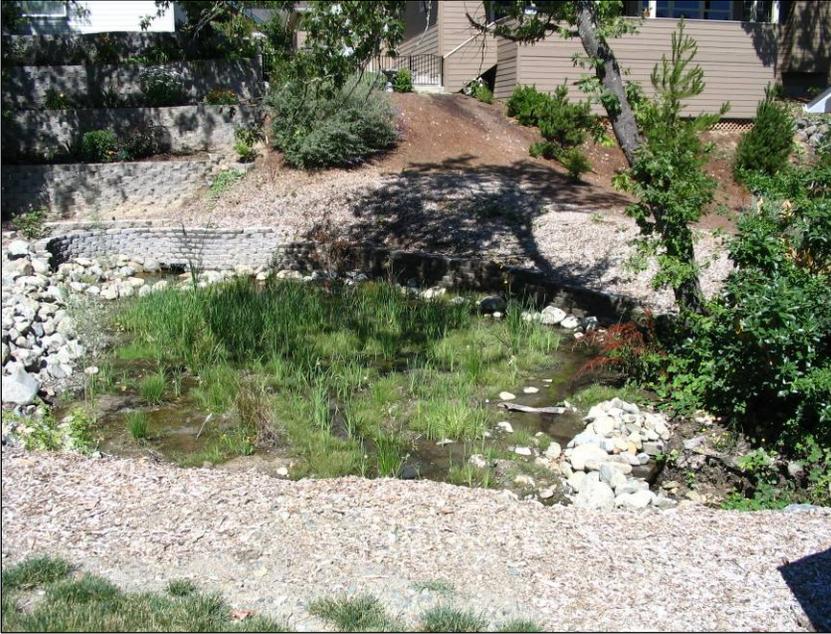
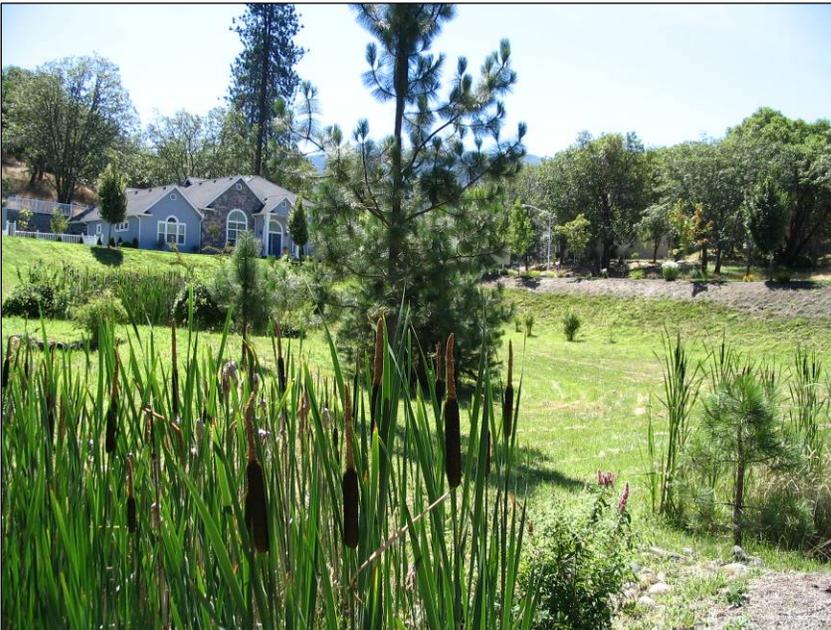
While these (oak and pine) may not be the optimum trees for wet areas, they seem to be surviving well, and, in the bottom picture, working to mitigate some stormwater run-off.
